Contract #: 04-0120F4Cty: SF/ALA Rte: 80 PM: 13.2/13.9File #: 69.28**WELDING INSPECTION REPORT****Resident Engineer:**Pursell, Gary**Address:** 333 Burma Road**City:** Oakland, CA 94607**Report No:** WIR-011095**Date Inspected:** 11-Dec-2009**Project Name:** SAS Superstructure**OSM Arrival Time:** 700**Prime Contractor:** American Bridge/Fluor Enterprises, a JV**OSM Departure Time:** 1900**Contractor:** Zhenhua Port Machinery Company, Ltd (ZPMC), Changxing Island **Location:** Shanghai, China**CWI Name:** Mr. Wang**CWI Present:** Yes No**Inspected CWI report:** Yes No N/A**Rod Oven in Use:** Yes No N/A**Electrode to specification:** Yes No N/A**Weld Procedures Followed:** Yes No N/A**Qualified Welders:** Yes No N/A**Verified Joint Fit-up:** Yes No N/A**Approved Drawings:** Yes No N/A**Approved WPS:** Yes No N/A**Delayed / Cancelled:** Yes No N/A**Bridge No:** 34-0006**Component:** Tower**Summary of Items Observed:**

WELDING INSPECTION REPORT

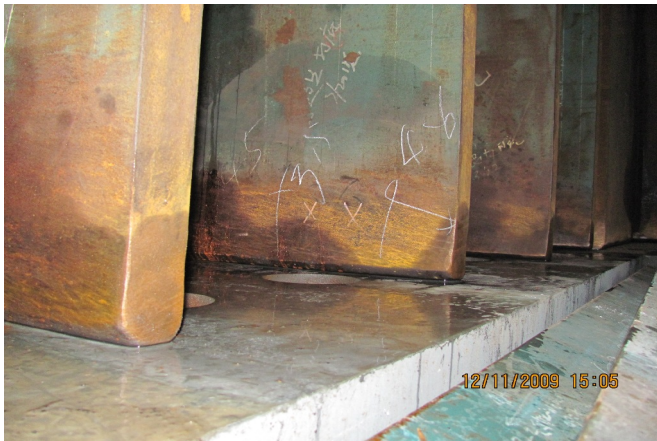
4.This QA inspector, Baskar Govindarajan, observed, after erection of North tower, Lift 1, by ZPMC personnel's,

a gap of approximately 5 mm between stiffener and base plate inside the shaft of Skin C. Photograph attached.
